TECHNICAL REPORT GL-81-2

15 MILE ROAD/EDISON CORRIDOR SEWER TUNNEL FAILURE STUDY DETROIT AREA, MICHIGAN

Geotechnical Laboratory
U. S. Army Engineer Waterways Experiment Station
P. O. Box 631, Vicksburg, Miss. 39180

January 1981

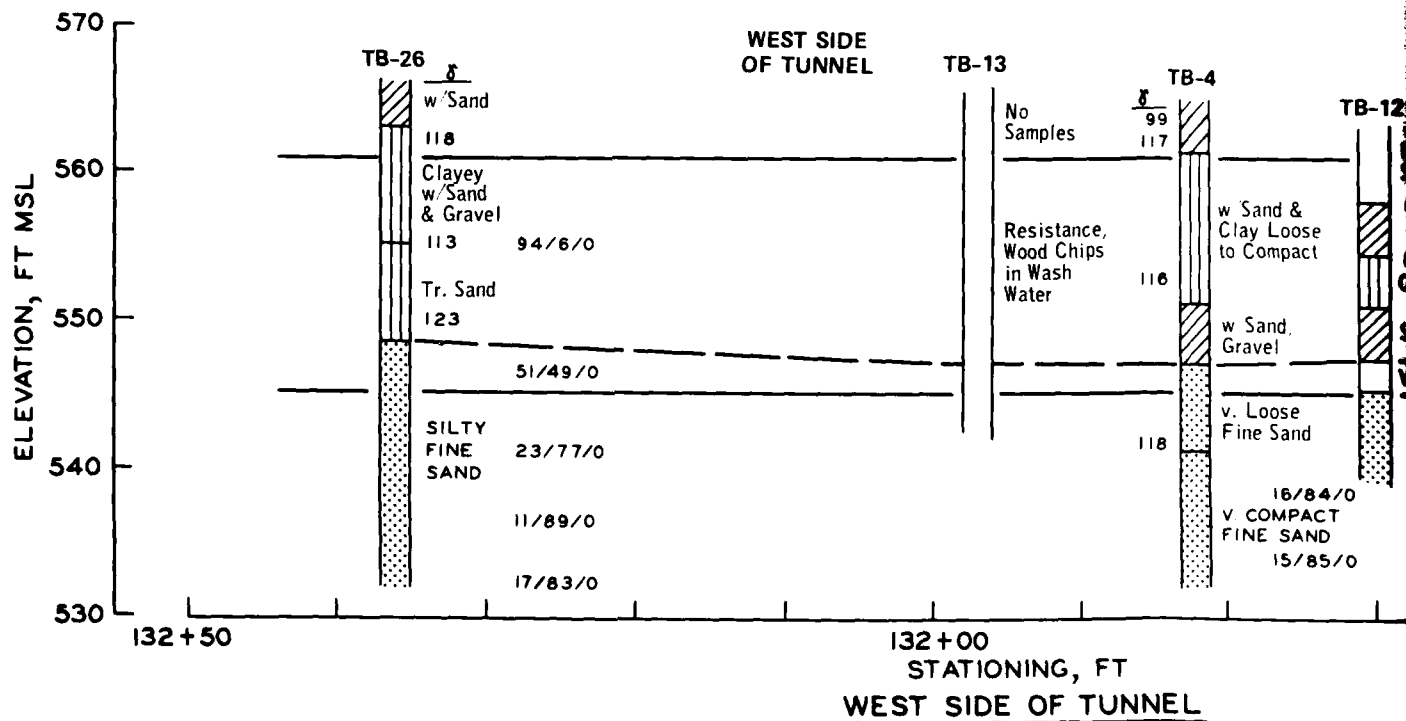
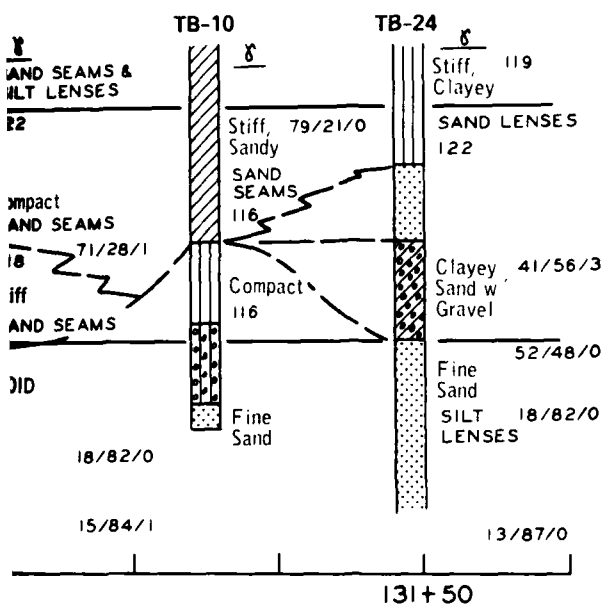
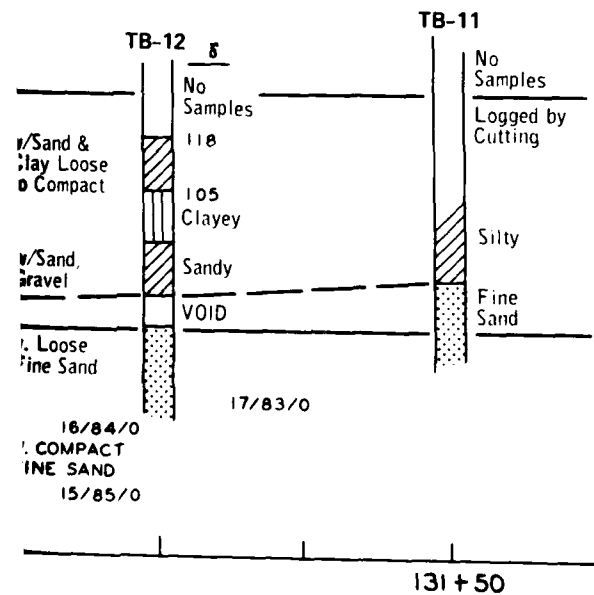
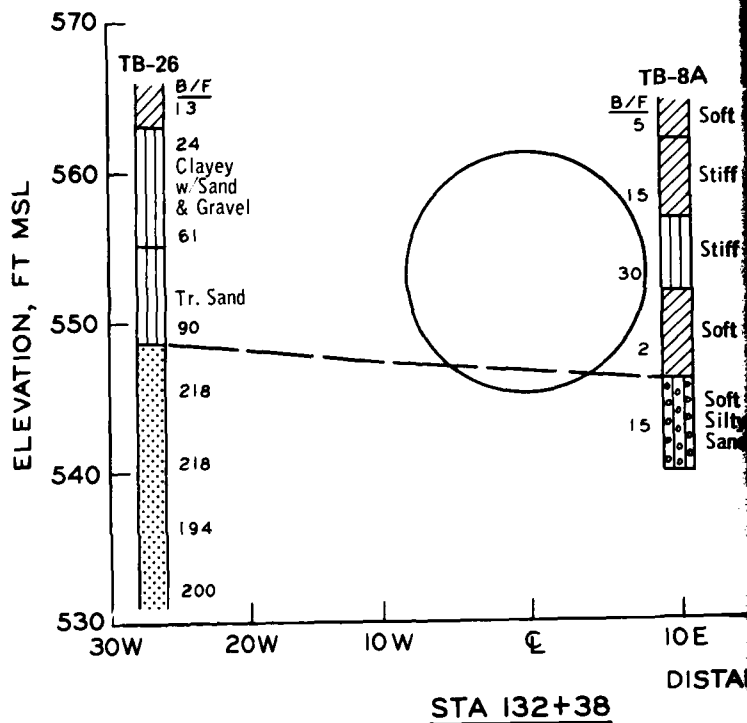
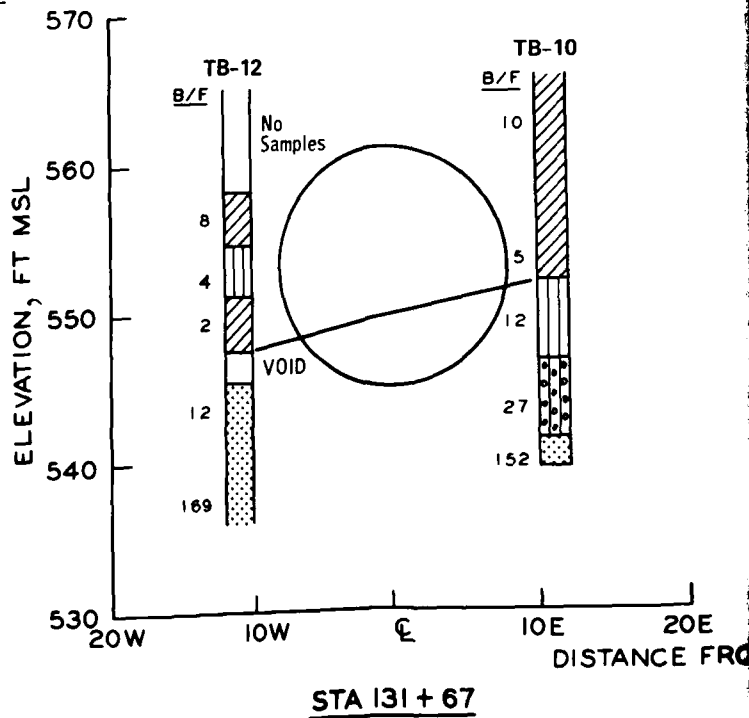
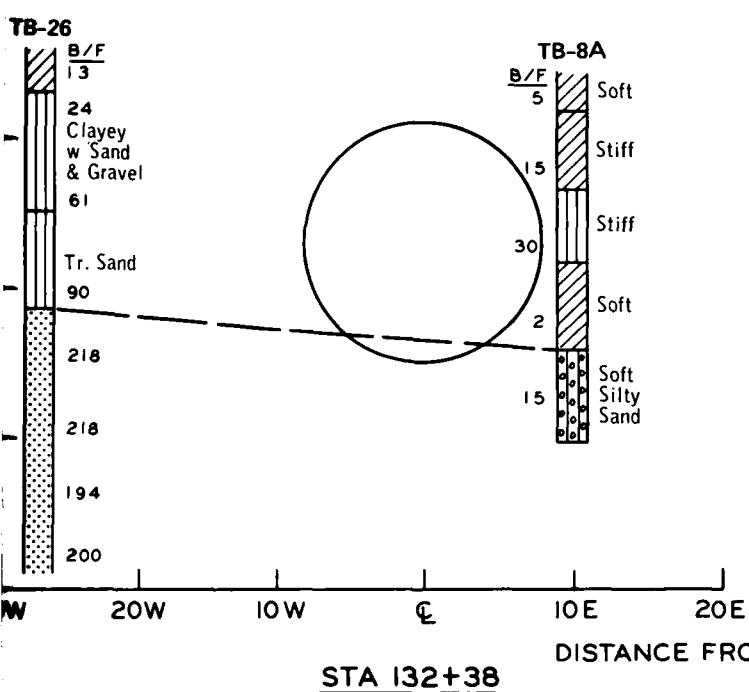
Figure 14. Profiles and sections in Distressed Area 1, 15 Mile Road/Edison Corridor Tunnel Failure Study

- d. Distressed Area 1. Detailed 1 to 1 profiles and sections constructed from logs of the closely spaced TB borings made in early February 1980 on either side of the tunnel, in the central portion of Distressed Area 1 are shown in Figure 14. The tunnel profile and sections are for the as-built location before distress. Silty sand, silt, and fine sand exist along the base of the tunnel; clay and silt strata exist above the sand. The material excavated during mining in this segment noted considerable sand along with clay, sandy clay, stones and rocks (Table 7). Borings TB-4 and 8A show loose sand and soft clay strata. Voids were also found adjacent to the invert in TB-5 and TB-12. The sections show the variable stratification on either side of the tunnel. Lines connecting similar strata indicate orientation of silt, clay, and sand around the tunnel periphery, before distress. The density values from split spoon samples are shown on the profiles in Figure 14. Although split spoon samples are considered disturbed samples, the dry densities (excluding the effects of water content) provide a relative measure or index of in situ conditions. Low density values are indicated for the soft to stiff clay above the crown at Sta 132+40 (TB-8 and TB-8A) and in the silt layer at Sta 131+40 (TB-12). Dry densities for other strata range from 113 to 129 pcf. These values are within the range for samples from other locations as shown in Figure 15. It should be noted from Figure 15 that there is a wide range in dry densities at the tunnel site. Thus, low density values may be a result of the natural variation in the complex stratification. Gradation data shown in Figure 14a indicates that the beach sand unit along the base of the tunnel is primarily a silty sand. The sand content increases with depth. Very low blow counts of 2 to 15 (compared to blow counts of 33 to 83 in preconstruction borings C-224 and C-176, Figure 9) can be noted close to the tunnel in Figure 14b. Final collapse of the tunnel crown at Sta 131+80 occurred during the time the TB borings were being drilled

(site settlement observations, para 61 c). Occurrence of the loose and soft soil conditions and low blow counts prior to collapse or as a result of collapse cannot be determined. Additional sections of soil stratification just north and south of Distressed Area 1 are shown in Figure 16. Although considerable variation in stratification persists in the east-west direction, TB-1 north of TB-26 (Figure 14a) shows the same silt-sand sequence with silt deepening to the north. Strata changes between TB-24 and WES-3 are shown directly in Figure 13. At Sta 134+50 (Figure 16), low dry densities and low blow counts were measured 17 ft from the tunnel sides in the silt to the west (TB-1) and silt and clayey sand to the east (TB-21), indicating loosening of these materials north of the distress zone. Figure 15 shows a lower range of dry densities in comparison to other locations. At Sta 130+15, south of Distressed Area 1 (Figure 16), dry densities and blow counts were generally higher than those at Sta 134+50 and in Distressed Area 1. The beach sand unit at Sta 130+15 has considerable sandy silt (TB-34). The section of Sta 119+90 in Figure 16 is referred to later.

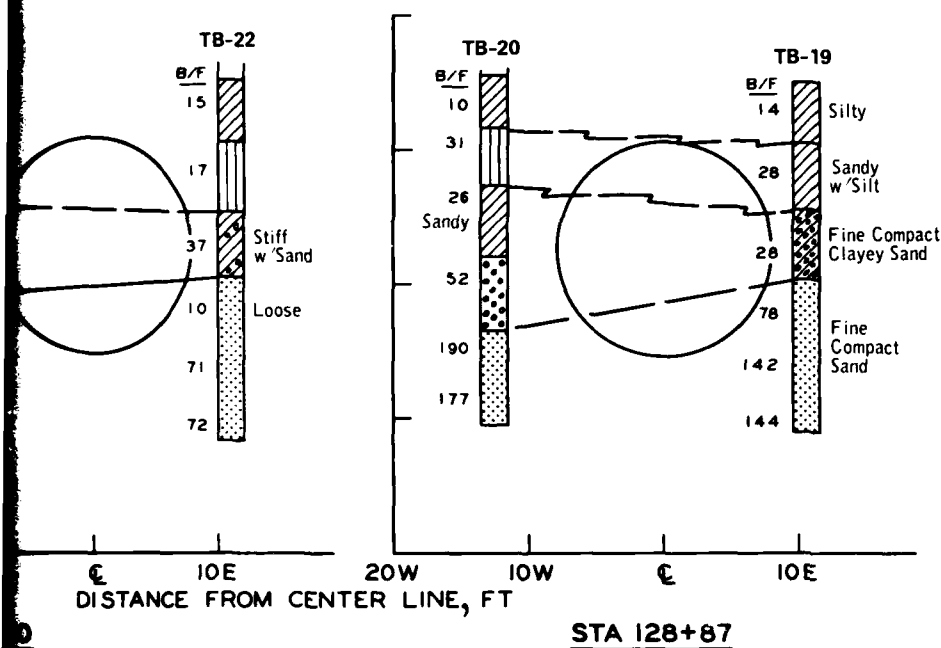
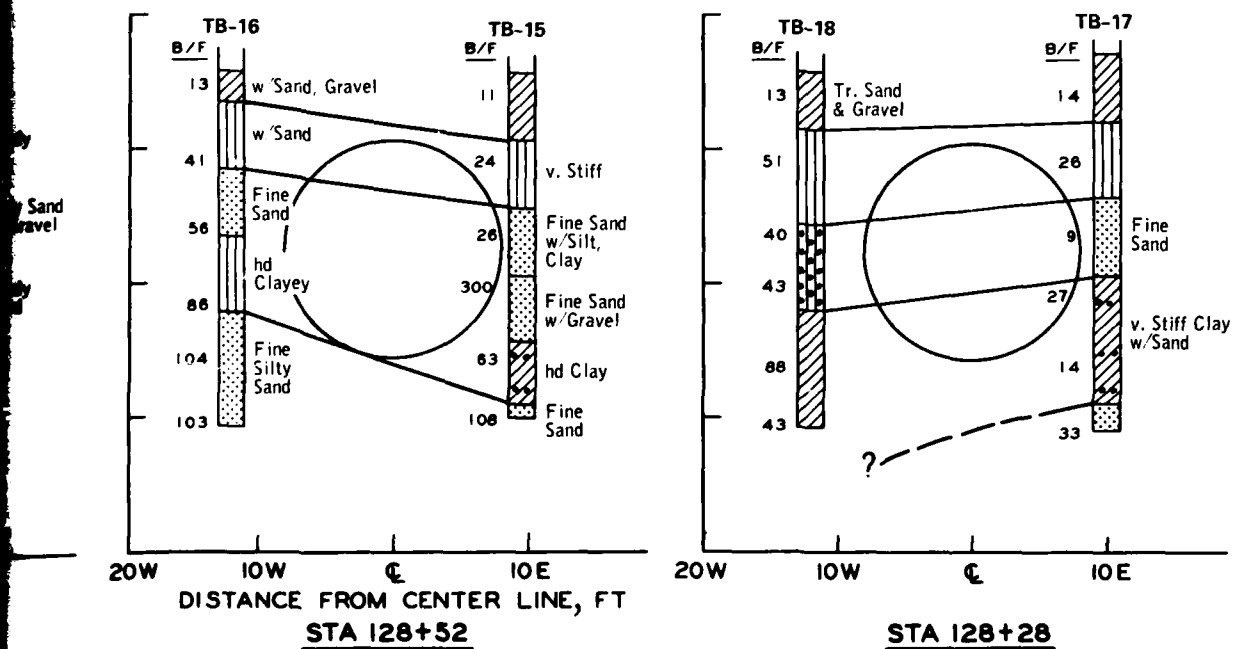
Figure 17. Profiles and sections along nondistressed tunnel segment between Distressed Areas 1 and 2, 15 Mile Road/Edison Corridor Tunnel Failure Study

hard sandy clay to clayey silt stratum dipping from the springline at Sta 129 to the tunnel base at Sta 128+50. These dry density values are compared with those at other locations in Figure 15. Only borings TB-22 and TB-17 encountered a loose sand interval with low blow counts of 9 and 10. Low blow counts of 8 to 20 in clays, just above the tunnel are similar to those in preconstruction borings C-224 and C-176 (Figure 9). High blow counts adjacent to the tunnel are also comparable to those for the preconstruction borings. The soil conditions along this undistressed segment are similar to conditions before construction.

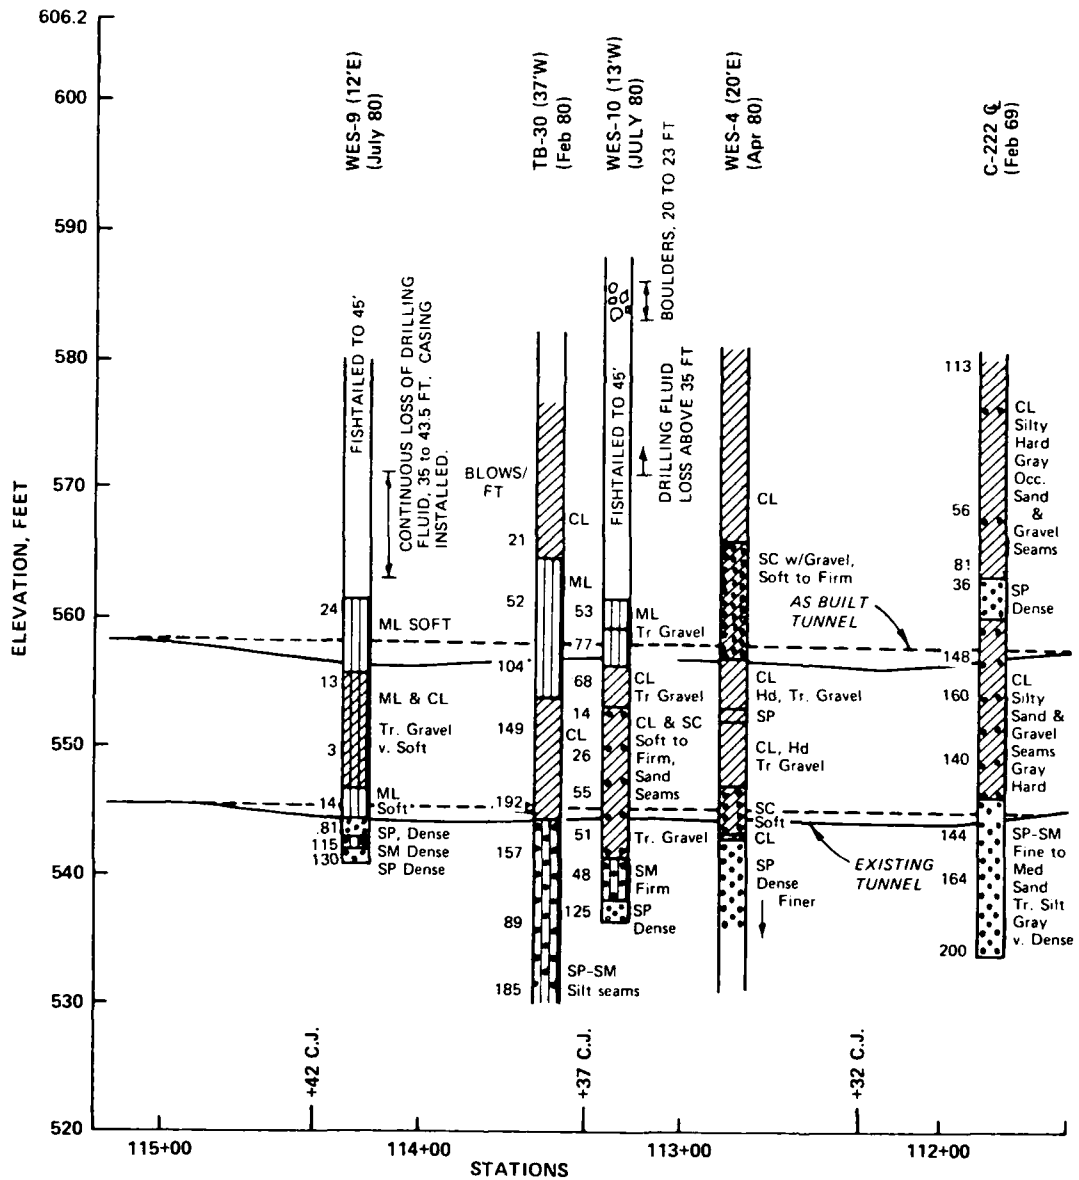
Figure 18. Stratification and soil conditions, Distressed Area 3

sand with much gravel (boring WES-4) are prevalent. A detailed section along this segment shown in Figure 18 indicates the sand and silt layers and prevalent sand seams. Both the as-built and after distress tunnel profiles are shown. Boring WES-9 and WES-10 adjacent to the tunnel sides lost considerable drilling fluid down to elevations 570 and 563. Drilling fluid from WES-9 was found entering the tunnel the day following completion of the boring. Very low blow counts were indicative of the soft to very soft soil conditions found in boring WES-9. Boring WES-10 indicated relatively low blow counts to a depth of 8 ft below the tunnel. The higher blow counts in boring TB-30 can be explained by the fact that this boring was 24 ft further west of the tunnel than boring WES-10, and soils at TB-30 were probably less affected by the tunnel distress. Both borings TB-30 and WES-4 indicated relatively high dry densities (Figure 15) which compare with those for samples from the preconstruction boring C-222. As discussed subsequently (para 61 g), the sand layers and seams are water bearing. Notes on tunnel excavation materials along this segment included "sand on bottom" (115+41 to 115+11), "sand seams in bottom" (114+66 to 114+36), "sand layer in face at springline" (113+71 to 113+31), "sandy bottom and top" (113+31 to 111) and traces of sand indicative of sand lenses from Stas 114+86 to 114+66 and 113+11 to 112+76. Seepage water was also noted from 113+11 to 112+76.

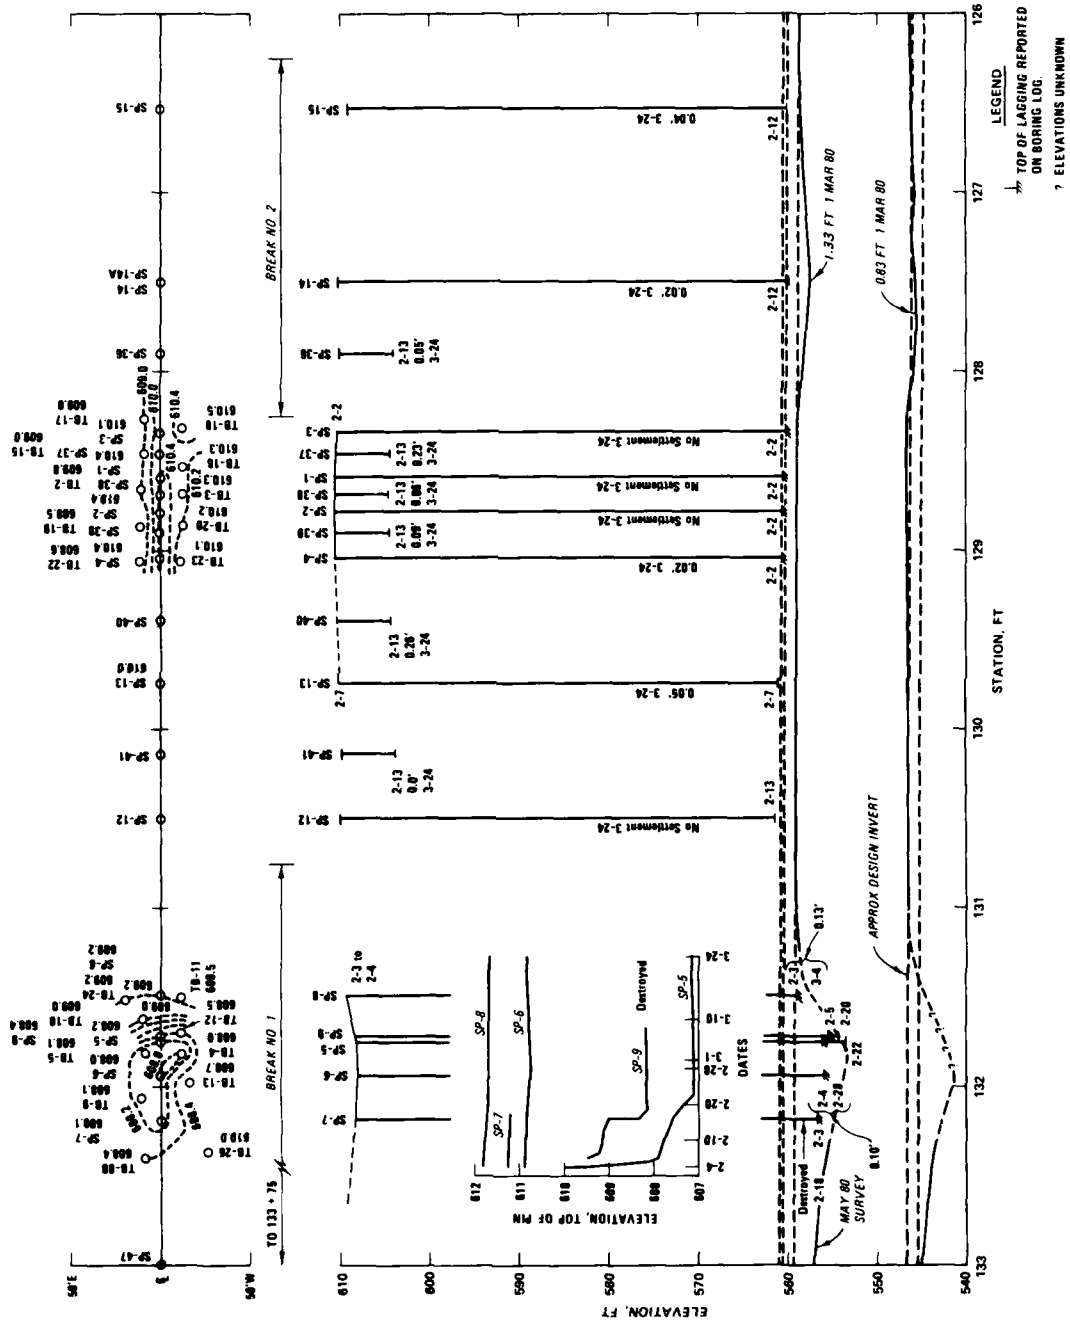
Figure 19. Settlement pin observations, Distressed Areas 1 and 2, 15 Mile Road/Edison Corridor Tunnel Failure Study

- b. Tunnel crown collapse, Distressed Area 1. In Distressed Area 1, some TB borings and grouting were completed before and others after the first settlement pin readings as summarized in Table 9. A summary of settlement pin data is shown for Distressed Areas 1 and 2 in Figure 19. The as-built and deformed tunnel profiles are shown in the figure for correlation with settlement pin data. When installed, pins 5 through 9 showed that the crown had sagged about 5 ft. Pins 5 and 9 indicated further movement totaling 1 to 3 ft from 5 February 1980 to 20 February 1980 (plot of elevation versus date in Figure 19). Table 9 shows that significant grout was injected in TB-4, TB-12, TB-5, and TB-10 on 2 February 1980 through 5 February 1980 before settlement readings. After initial pin readings, grout was injected in TB-11, TB-8A, and TB-6 on 6 February 1980 with 50 cu ft taken in TB-11 and 150 cu ft in TB-6. After completion of the TB borings on 8 February 1980 and grouting on 6 February 1980, pins 5 and 9 showed an additional downward movement of the crown. Based on this sequence of events, it is possible that further fall-in of the crown and worsening of distress could have been due, in part, to the boring and grouting operations.

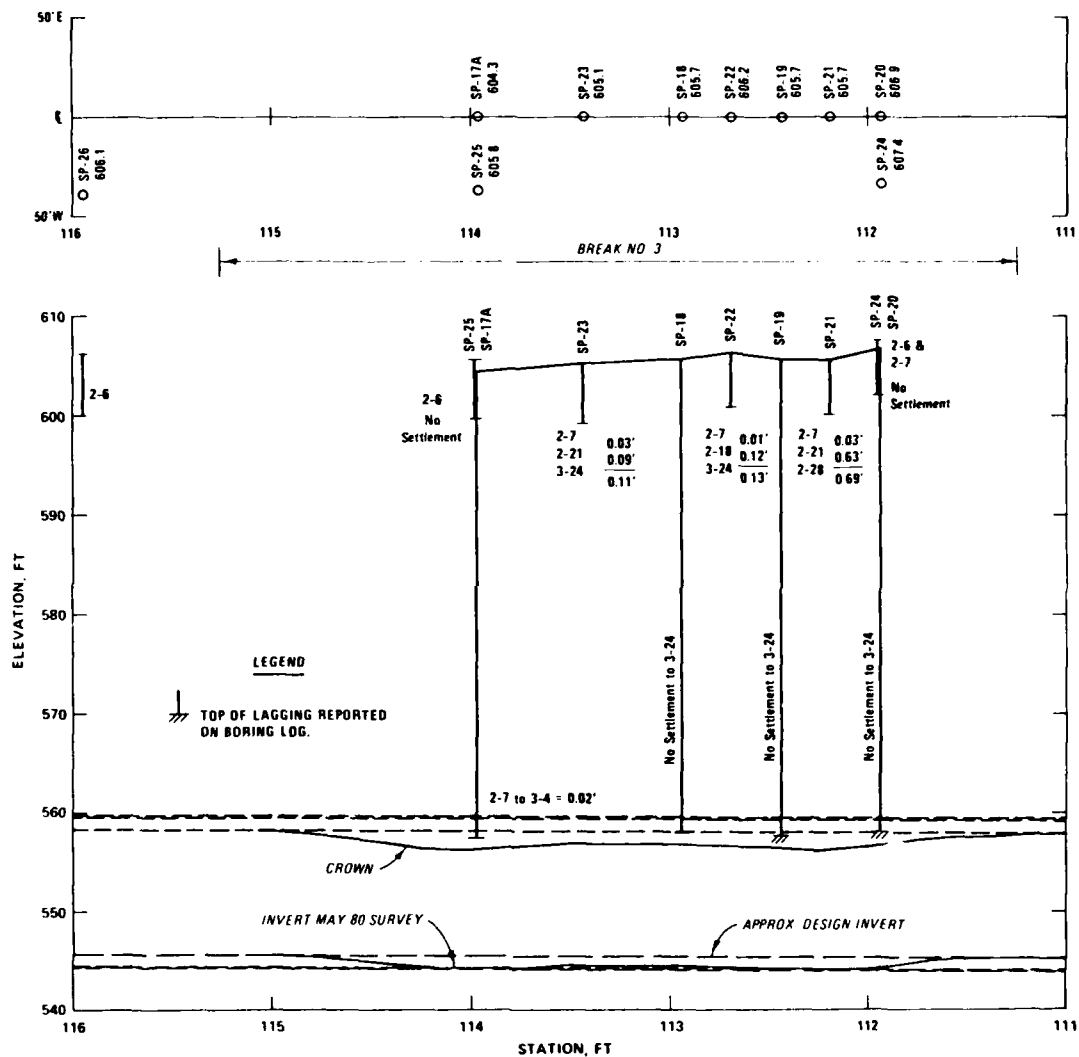
Figure 20. Settlement observations, Distressed Area 3, 15 Mile Road/Edison Corridor Tunnel Failure Study

- f. Settlement of Distressed Area 3. The settlement pin data for area 3 is summarized in Figure 20. The tip elevations of the pins indicated significant crown displacement had taken place before pins were installed on 6 February 1980. The deep pins recorded as being in contact with the lagging (SP-19 and 20) showed no further crown settlement as of 24 March 1980. SP-18 founded at the same depth as SP-20 also showed no settlement, while SP-17A indicated 0.02 ft on 4 March 1980. The tip elevations of the pins agree closely with the estimated existing top of tunnel lagging. Shallow settlement pins, along the tunnel centerline, indicated settlement of 0.11 ft to 0.60 ft which tend to correlate with the variation in tunnel crown movement. Pins SP-25 and SP-24, offset 38 ft west of centerline indicated no

settlement. It is possible that a narrow surface depression formed as a result of tunnel settlement.

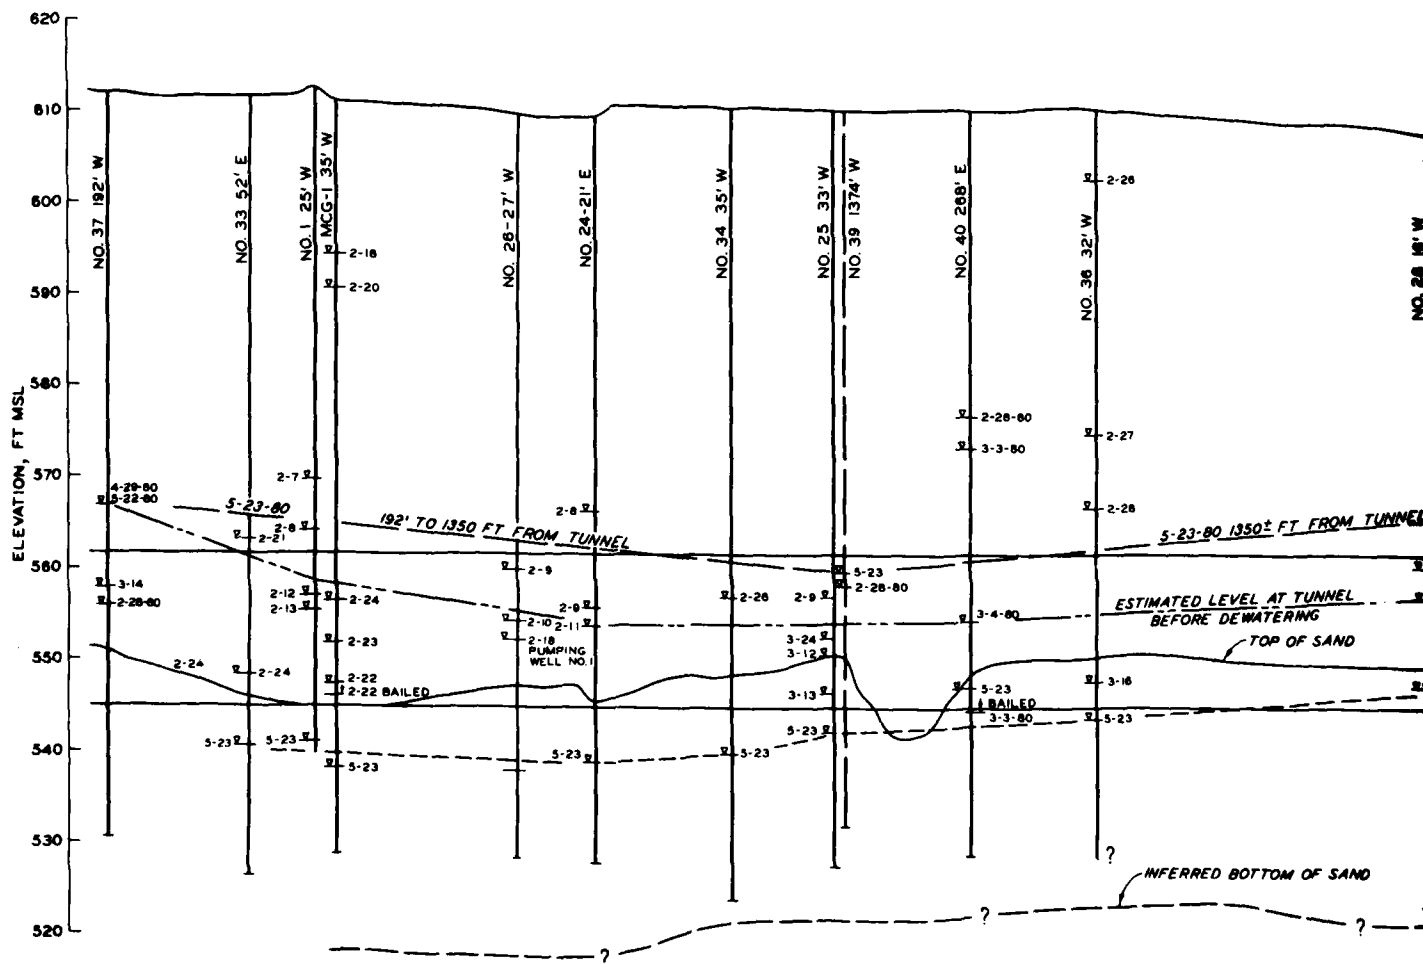
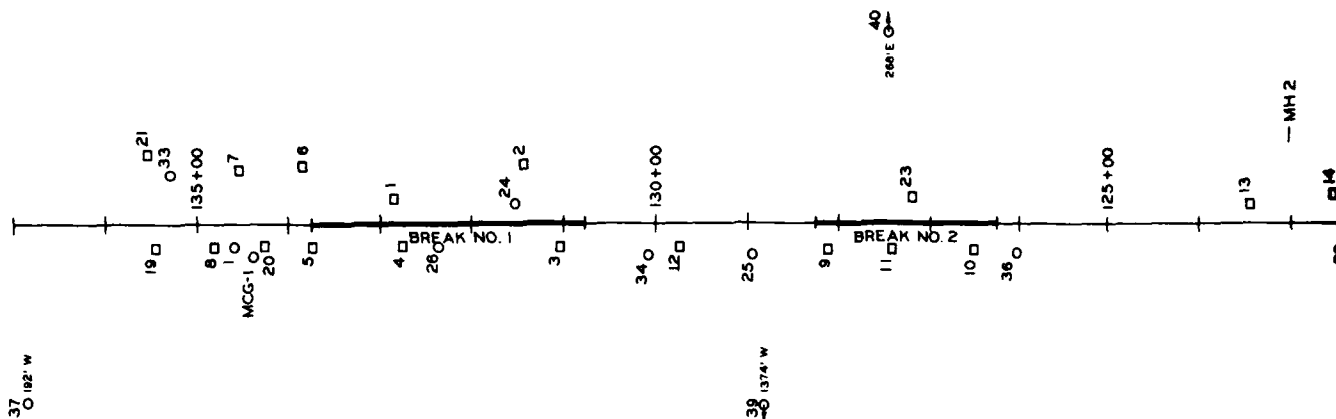
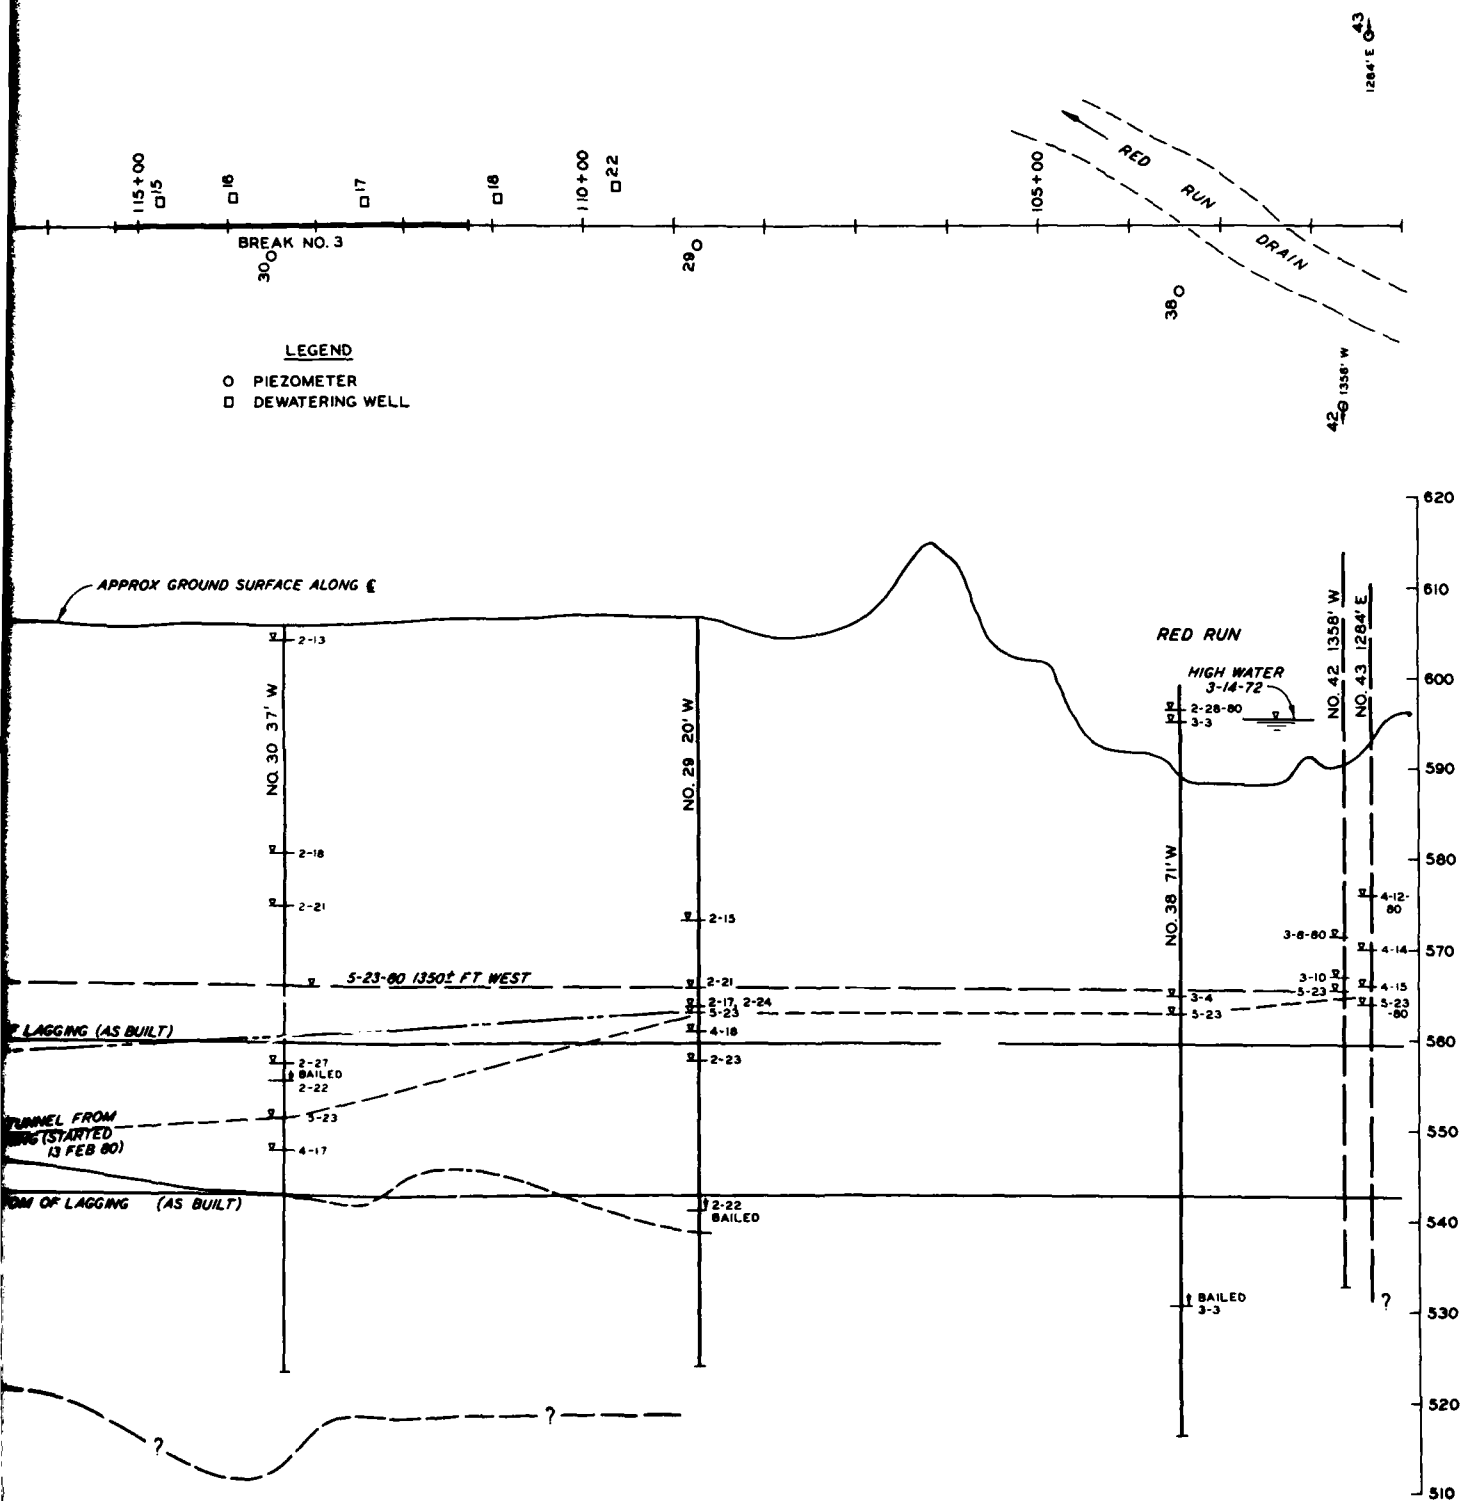
Figure 21. Summary of groundwater conditions, 15 Mile Road/Edison Corridor Tunnel Failure Study

- (3) Groundwater levels. Three water profiles are shown on Figure 21. The upper profile is for conditions 192 to 1400 ft away from the tunnel after stabilization of piezometer levels in the sand which were not significantly influenced by dewatering. The second profile is for piezometers near the tunnel before the effects of dewatering. The third and lowest profile is along the tunnel after dewatering had its maximum effect. The two lower profiles slope upward to the south where they tie into the profile unaffected by dewatering. This trend indicates increased stratification of clays and water bearing sands to the south, as indicated by borings in Distressed Area 3 (Figure 18). The trend is supported by the fact that the five wells from Sta 115 south could not pull the water level as far down as wells north of Sta 122 (Figure 21). The water profiles before dewatering along the tunnel and at a distance of 1300 ft to 1400 ft from the tunnel dip down in the vicinity of Distressed Area 2. The reason is unclear but could be caused by a southwesterly seepage trend since the beach sand appears to slope to the southeast (based on the top of beach sand at elevations 560 in boring A-34 on Schoenherr Rd east of the site and elevation 530 in boring C-26 on Maple Rd to the west). Also the dip in the top of the beach sand at Sta 128 could indicate a buried channel with more permeable strata below elevation 540.

- (4) Groundwater conditions. Groundwater levels at elevations 581 in 1969 and 576 in 1971 near Sta 133 (see (2) above) indicates a perched water table in the clay at a depth of 29 and 34 ft, respectively. Groundwater encountered at elevations 545 in 1971 and 550 in 1980 in the beach sand near Sta 133 was seepage water under pressure. An artesian condition exists in this sand because piezometers at this location (No. 37) and west of the site (No. 39) in the beach sand, showed a significant rise in water levels for several days after initial readings. This is confirmed by the local groundwater conditions (para 46) and by bailing tests in piezometers MCG-1, Nos. 40, 29, and 38 (Figure 21). The estimated groundwater profile before dewatering is a measure of the reduced artesian pressure in the beach sand caused by the distressed tunnel segments acting as a drain. This condition is evident in Figure 21 from the difference in profiles before dewatering, and 1300 to 1400 ft from the tunnel, the level in piezometers No. 37 near 15 Mile Road (Sta 137) and No. 43, 1284 ft east of Sta 101+40. The latter groundwater elevations correspond to the natural artesian pressures in the sand

away from distressed segments of the tunnel. This higher water profile represents conditions that could have existed prior to start of distress and tunnel cracking. The profile before distress could have been higher or lower at times from 1972 to 1980 depending on rainfall and recharge conditions as described in para 57. From the above conditions, it appears that the sand along the tunnel base and tunnel construction joints was subject to water pressure heads of at least 13 ft to 22 ft above the invert during the interim period from 1972 to 1980.

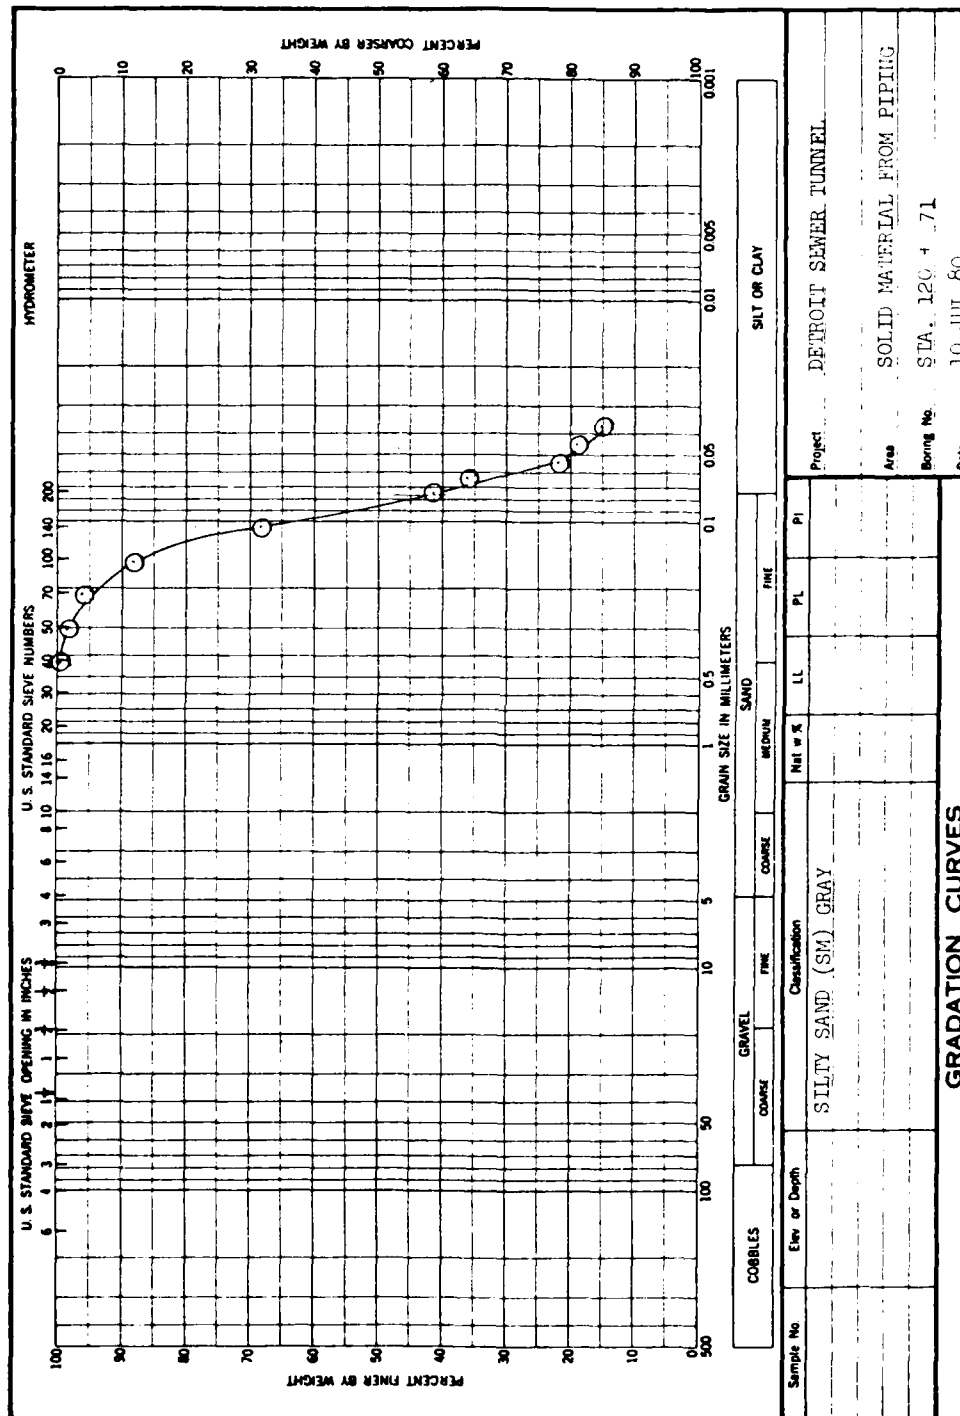
Figure 24. Gradation of sand piped into tunnel at Sta 120+71,
15 Mile Road/Edison Corridor Tunnel Failure Study

a. Sand piping and tunnel leakage. During the field visit of WES structures and concrete engineers (just after cleaning out of the tunnel south of break 1) on 15 May 1980, seepage water and fine sand were observed flowing in at the invert of a construction joint at Sta 120+71. The water pressure at this location was equal to a head of about 2.5 ft above the base of the tunnel (see Figure 21). A photograph of this condition is shown in Figure 22. This location is in the nondistressed segment where waterstops were not placed in construction joints and where sand exists along the invert as shown in Figure 23. A sample of the sand was obtained and the gradation is shown in Figure 24. This gradation is very similar to that for the natural sands along the base of the tunnel (see soil test results, para 64). When a concrete core at Sta 117+70 (23 May 1980), 2 ft above the invert on the east side, was taken (with the last 0.05 ft of concrete drilled using a 2-in. air hammer), water seepage began piping sand into the hole. The water pressure at this location was equal to a head of about 2.5 ft above the wood lagging at the base of the core. Again at Sta 117+25, water seepage piped sand into the tunnel after a concrete core at the invert was removed from the hole. On several occasions, a packer in one of the core holes near the invert was knocked out during bracing operations and water seepage piped 1 to 2 cu ft of sand into the tunnel. Seepage also occurred from 2-in.-diam holes drilled through the tunnel wall to check soil conditions. After completion, a wooden plug was inserted. Several days later seepage, as shown in Figure 25, was evident around the plugs south of Sta 122+82. When some of the

- d. Piping susceptibility. Because of the heterogeneous quantities of sand, clay, and silt in the samples and variation in erosion, a quantitative scale of piping susceptibility for the sands and silts cannot be established. However, it was evident that the sands and silts readily piped under water pressures as low as 3/4 to 2 psi. This pressure is equal to a head of water of only 1.7 to 4.6 ft. The first sample tested was predominantly fine- to medium-grained sand and began piping rapidly under the low water pressure of 3/4 psi. The gradation of the piped material versus material left in the sample is shown for tests on sample WES-1-34 and WES-1-38 in Figure 39. The piped material gradation is similar to silty sand piped into the tunnel (Figure 24).

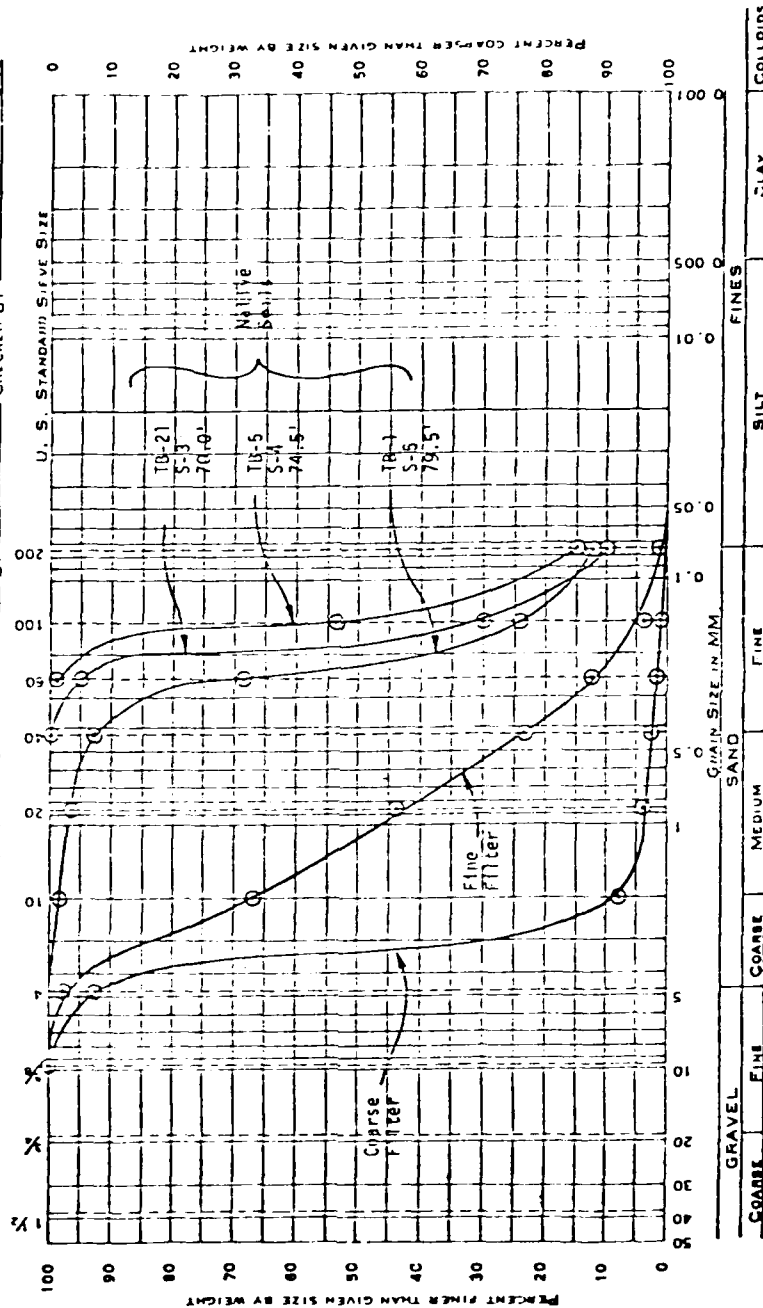
Figure 33. Gradation of samples from borings TB-1, TB-5, and TB-21, 15 Mile Road/Edison Corridor Tunnel Failure Study

temporary bypass and pumping shaft. The curves of interest are those labeled "native soils" for depths of 70 to 79.5 ft from TB-1, TB-5, and TB-21. These borings were located just north of and in break area 1. During clean out of break area 1, a large amount of sand was found under other soil and concrete in the tunnel. The lower segment of the tunnel at break 1 had settled about 5 ft into sand along the base of the tunnel. The gradations for two jar samples from the sand deposit in the tunnel are shown in Figure 34 and are similar to gradations for the silty sand from Sta 120+71, sample S-4 (TB-5) and sample 38 from boring WES-1.

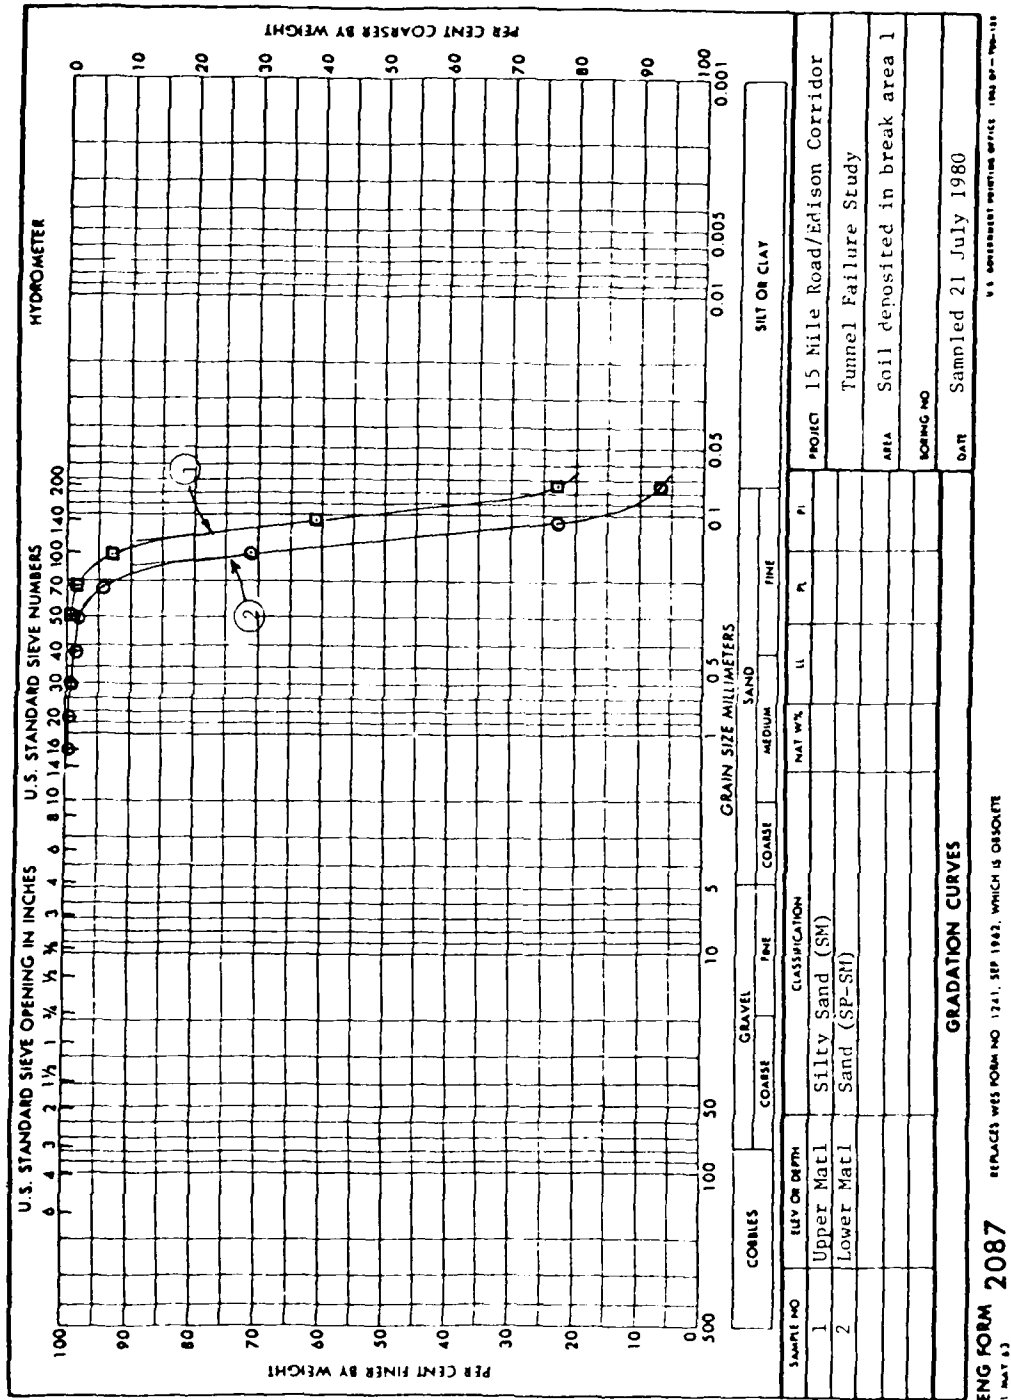
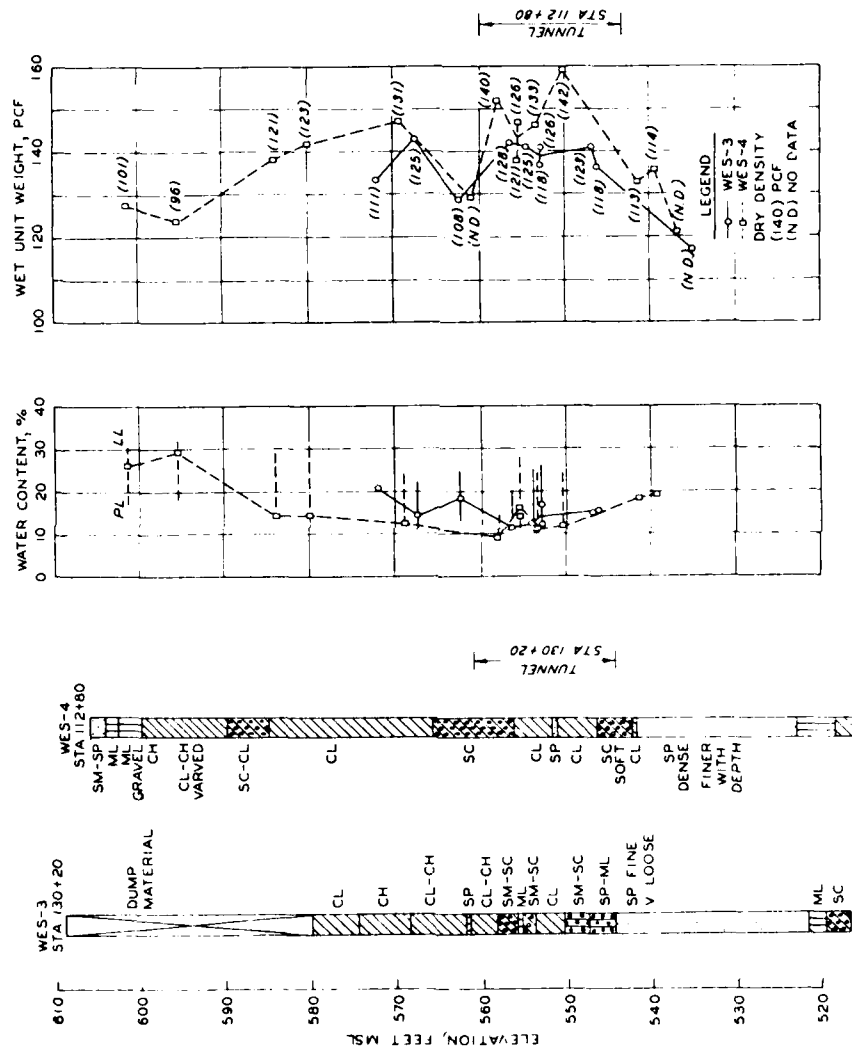
Figure 35. Water content, plasticity, and wet unit weight versus depth

- a. Water content. The water contents of samples for Sta 132+20 were higher at depth than at Sta 112+80, perhaps due to the greater water seepage source from the dump material and the existence of more plastic clays at Sta 130+20. Water contents of samples from boring WES-4 (Sta 112+81) between elevations 590 and 555 were higher than those before construction at Sta 111+80 (boring C-222, Figure 10). These are the only two borings close enough to compare water contents after distress with those before construction. Thus, water contents after tunnel distress in area 3 appear to be higher than before construction. The water contents before tunnel distress could have been slightly higher since about two months of dewatering and drainage of soils around the tunnel occurred before boring WES-4 was made. In the upper 15 ft at Sta 112+81, water contents were near the liquid limits, indicating normally consolidated soils; at depths below elevation 590 water contents were close to the plastic limit, indicating an overconsolidated condition.

- b. Wet unit weights. The total unit weights (as indicated by wet density) are shown in Figure 35 since they relate to the existing total overburden pressure. Wet densities of about 129 to 143 pcf for samples from Sta 130+20 (under the dump) are generally lower than

those at Sta 112+81 (dry densities also are lower). The wet densities at Sta 112+81 increase with depth to 152 pcf (at the tunnel crown in Distressed Area 2), then show a marked decrease for the sandy clay above the springline. However, this decrease may be a result of natural variation since unit weights for samples from boring WES-4, between elevation 553 to 558 (Figure 35), are almost the same as those for samples from boring C-222 (Figure 10). The density of the silty sand samples (below elev 539, Figure 35) are not as dense as would be expected from the blow count data. Since sampling causes stress release, the samples tend to expand and may be further disturbed during handling and transit to the laboratory. This is especially true for silty sand and sand samples. Consequently, unit weights can be lower than they are in situ. When clay samples were opened in the laboratory, some were noted to have cracks indicative of stress release. Consequently, all test results should be considered with the above in mind.
